Engineered Wood Fiber
Accessibility Testing

Review and Analysis of Preliminary Results

8/20/2013

Henderson Consulting Services, Inc.

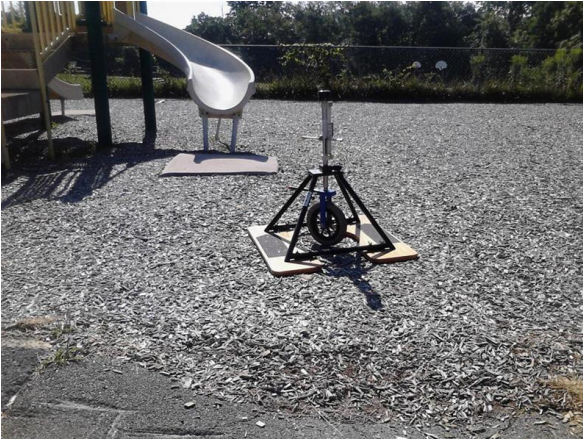
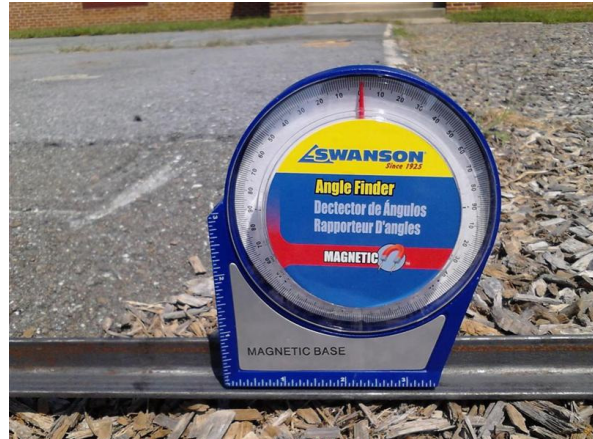
Location: Entry to play area just off of asphalt.

Rotational Penetrometer Readings : Firm- .39 Stability - .77
Running Slope reading :- 1% Cross slope reading: - .5%
Change in level : None Gaps : None

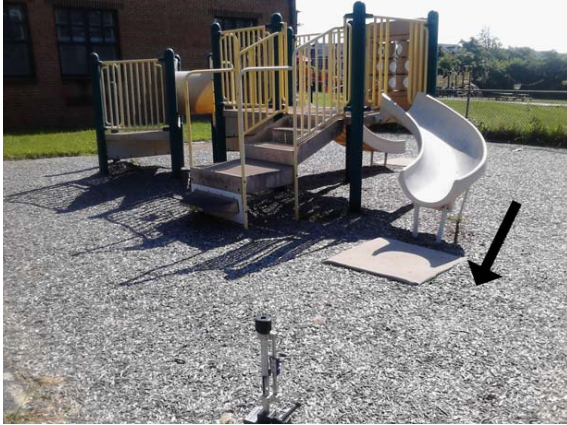
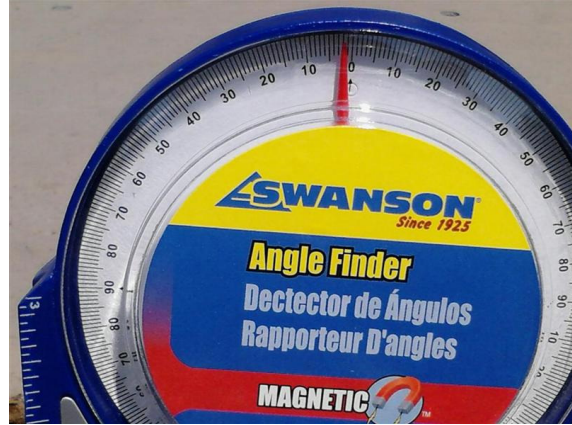
Location: First slide exit – beside mat.

Rotational Penetrometer Readings : Firm- .43 Stability - .90

Running Slope reading :- 2% Cross slope reading: - 1%

Change in level : Yes (between mat and surface-see picture) Gaps : None

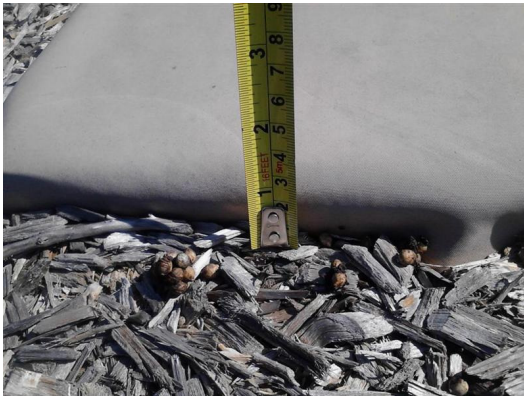
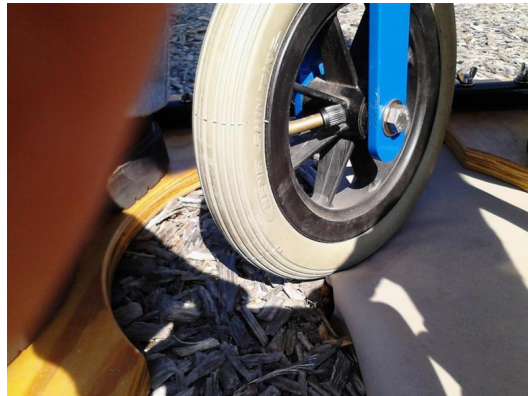
Note: Even with the change in level, the mat was pliable and when pressure was applied by the wheel of the Rotational Penetrometer (approx 48lbs) it compressed down to level with the surrounding surface. (see above picture) This would simulate a child rolling over this area with little effort between the surface and the wear mat.

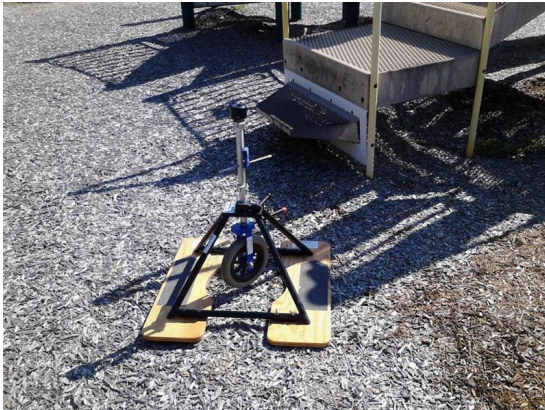
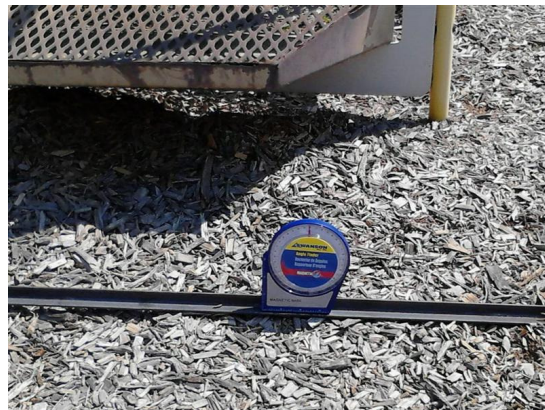
Location: Near 1st transition platform.

Rotational Penetrometer Readings : Firm- .38 Stability - .77
Running Slope reading : 7% Cross slope reading: - 0%
Change in level : None Gaps : None

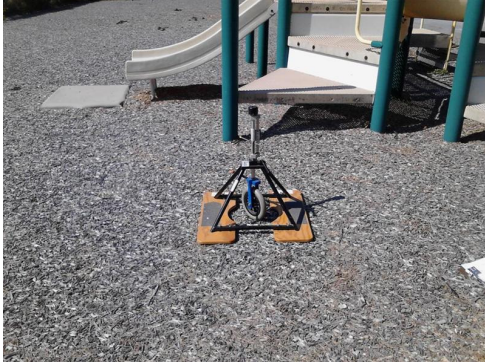
Location: Second transition platform.

Rotational Penetrometer Readings : Firm- .38 Stability - .76

Running Slope reading : 0% Cross slope reading: - 2%

Change in level : None Gaps : None

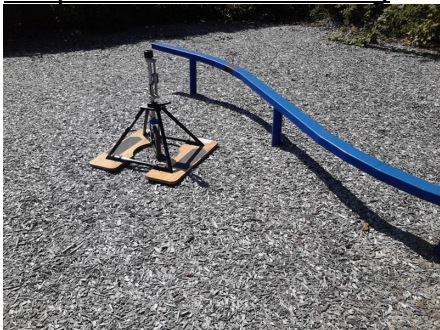
Picture: Balance beam area.

Rotational Penetrometer Readings : Firm- .43 Stability -.80

Running Slope reading : 10% Cross slope reading: 1%

Change in level : None Gaps : None

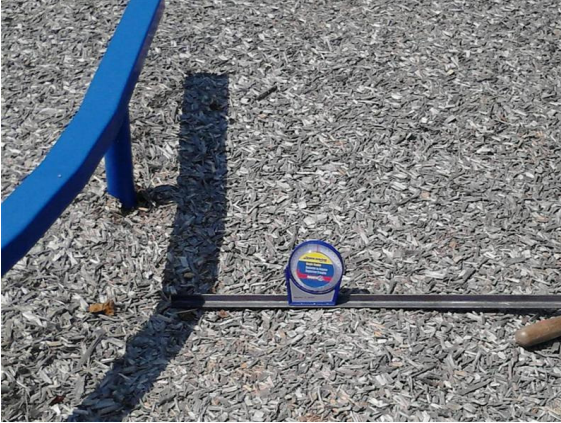
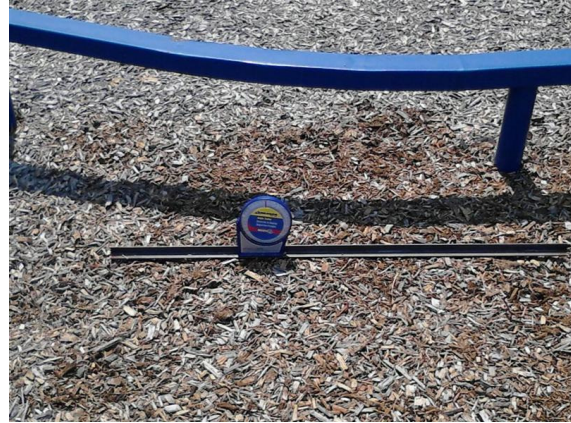
Running slope area needed maintenance. Cross slope was fine.

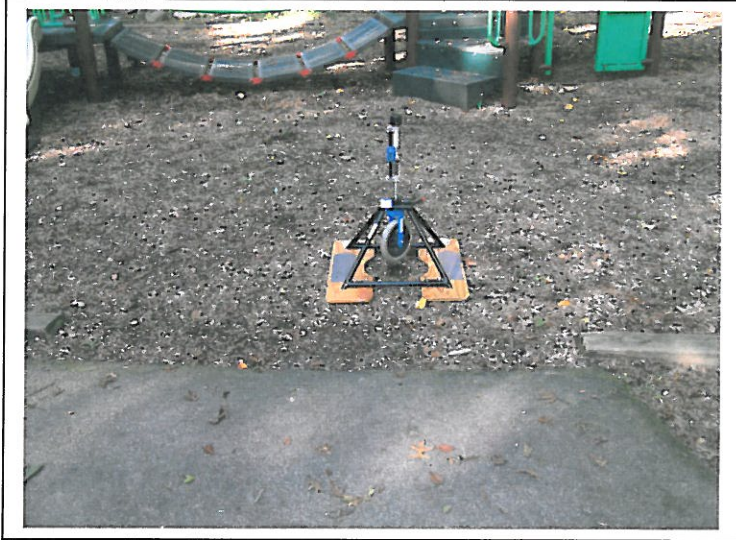
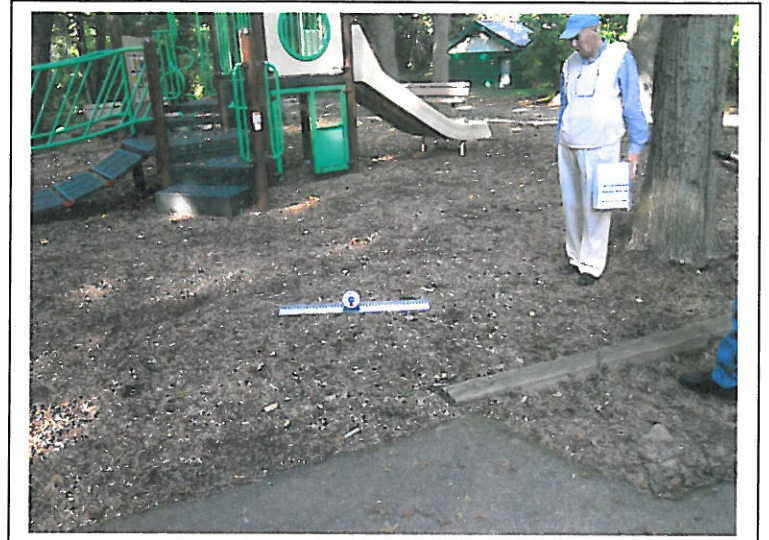
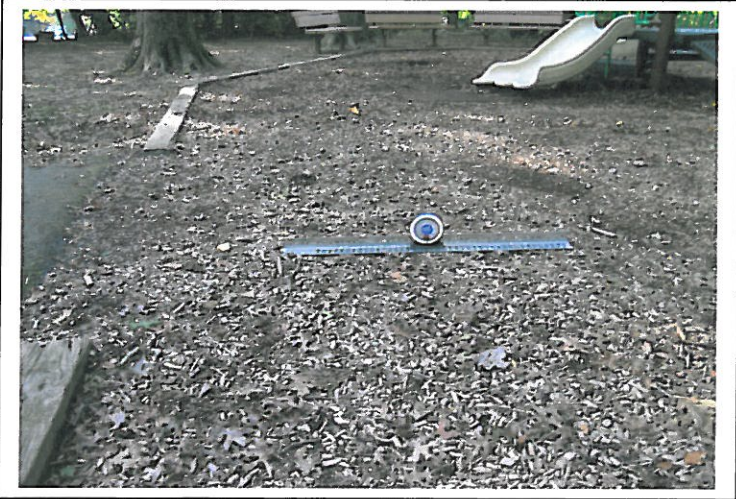
Area 1: Entranceway to the playground

Firmness	Stability	Running Slope	Cross Slope	Change in Level	Openings	Surface Prep
.35	.59	3.5%	0%	None	None	None

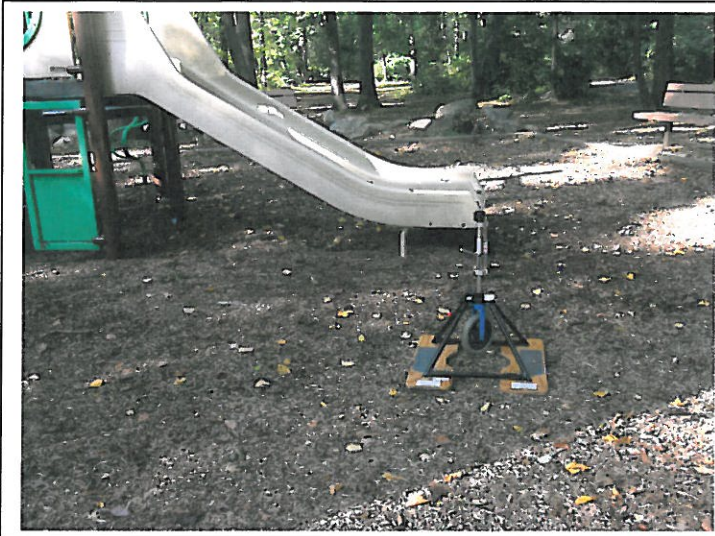
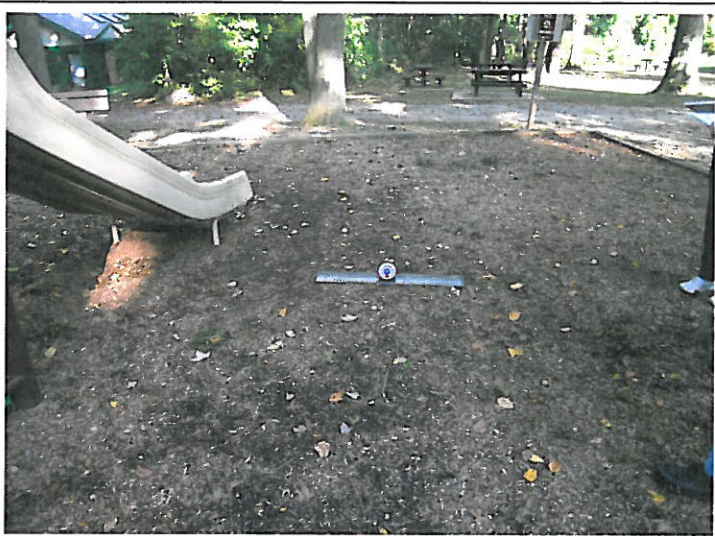
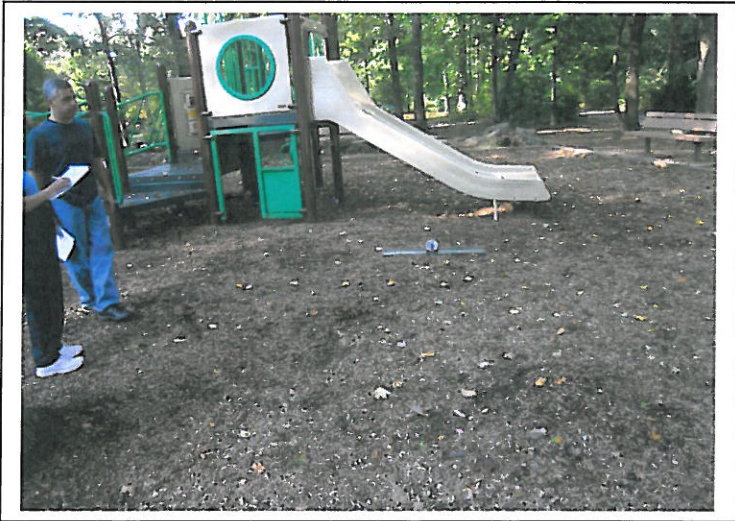
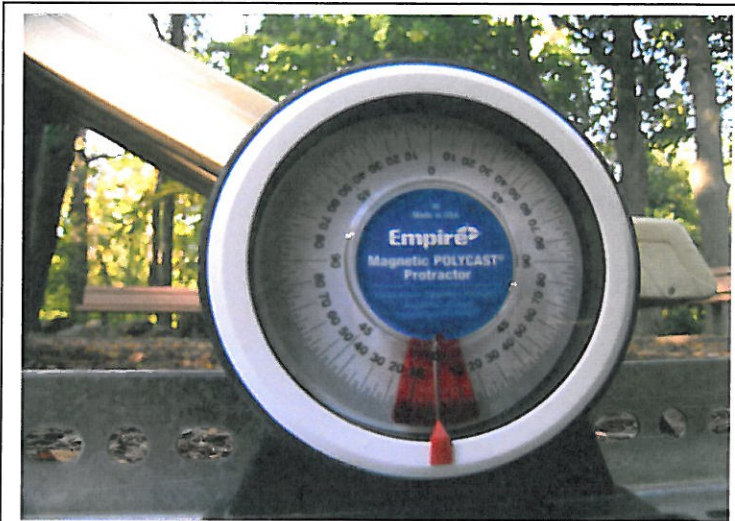
Area 2: An accessible route within the playground

Firmness	Stability	Running Slope	Cross Slope	Change in Level	Openings	Surface Prep
.42	.74	0 %	0 %	None	None	None

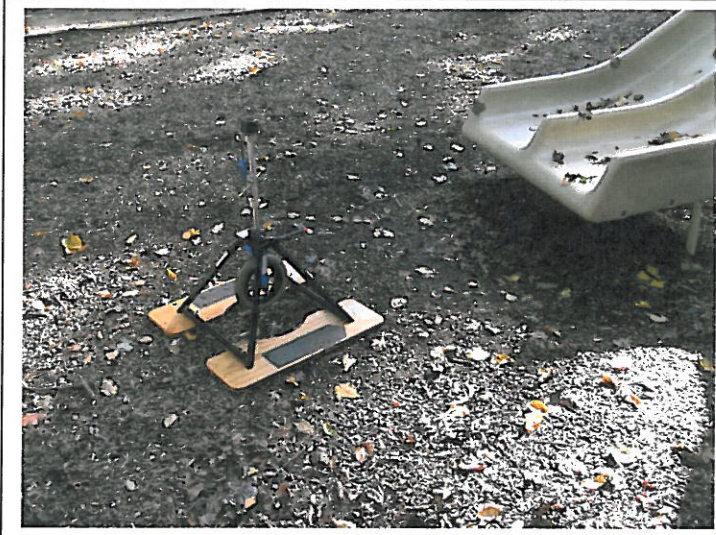
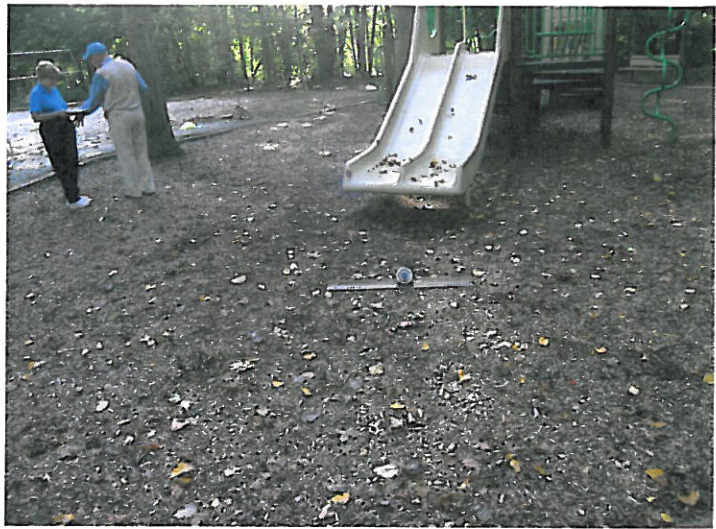
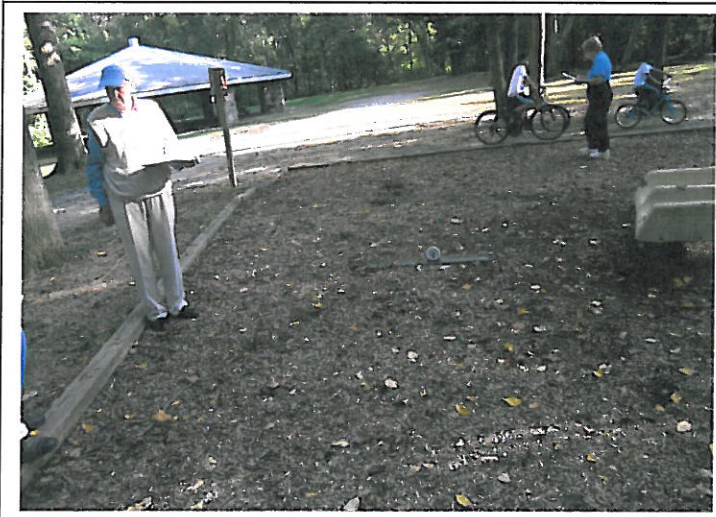
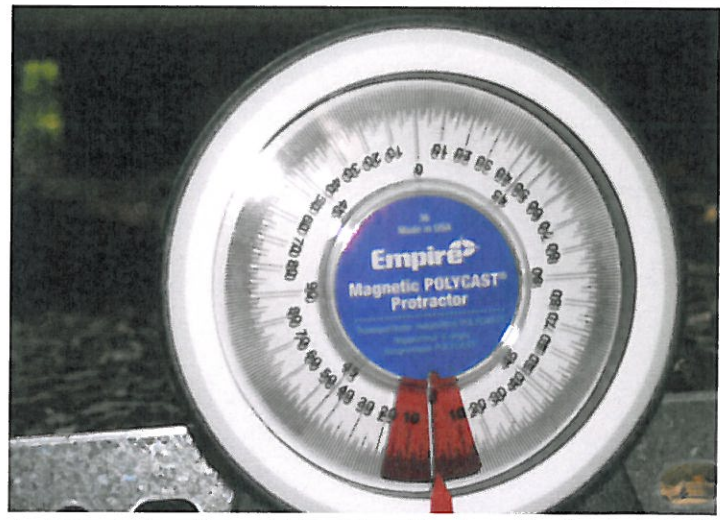
Area 3: Area at the base of a slide

Firmness	Stability	Running Slope	Cross Slope	Change in Level	Openings	Surface Prep
.38	.68	0.9%	0.9%	None	None	None

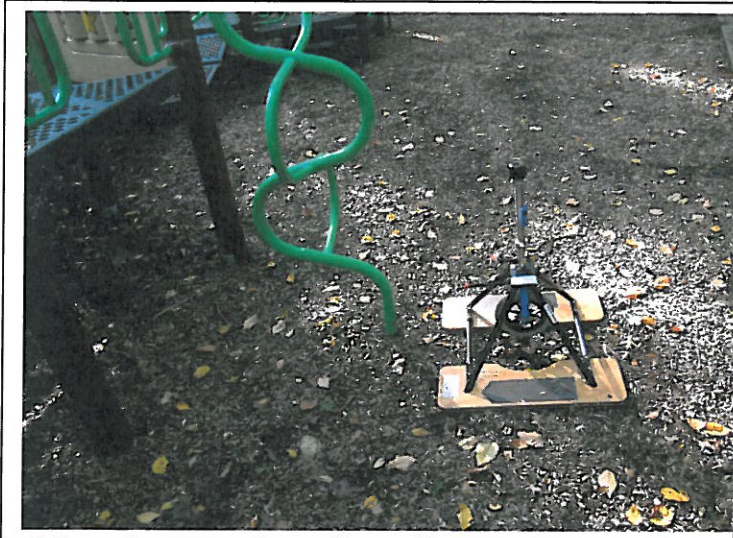
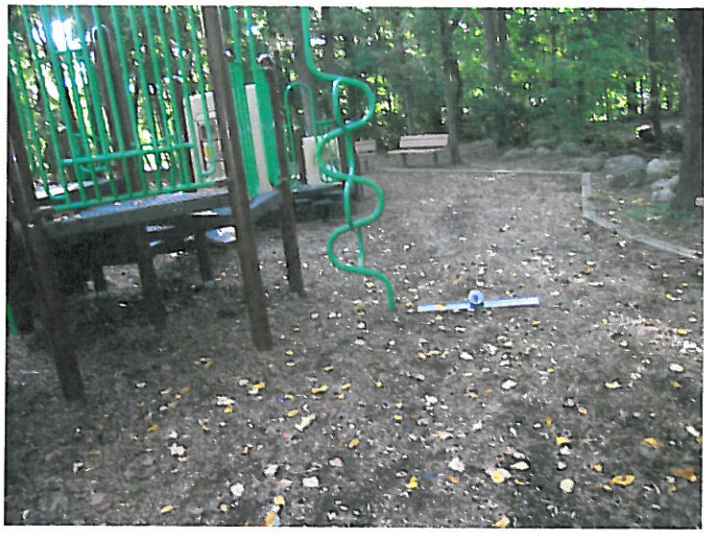
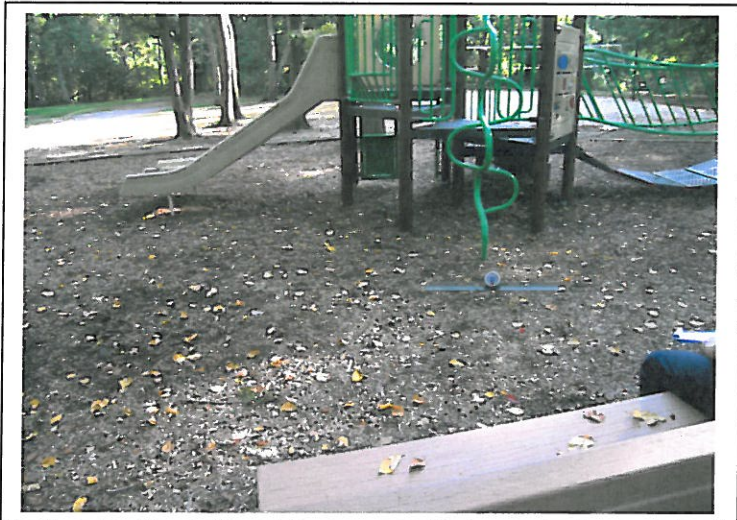
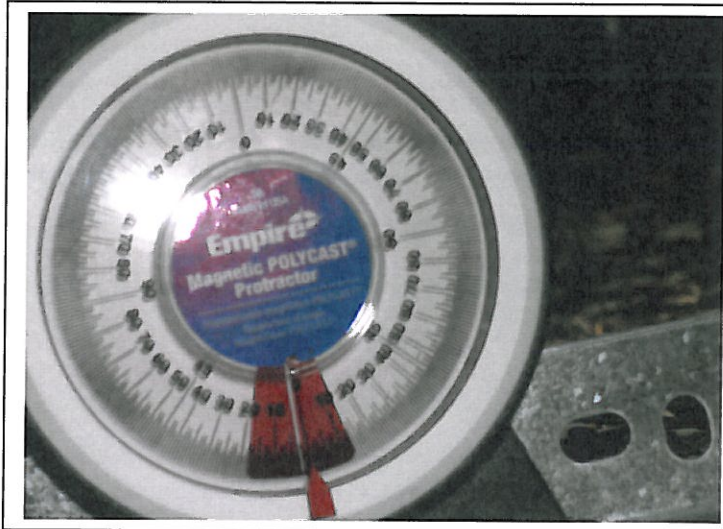
Area 4: Area near the base of a sliding pole

Firmness	Stability	Running Slope	Cross Slope	Change in Level	Openings	Surface Prep
.33	.54	3.5%	3.5%	None	None	None

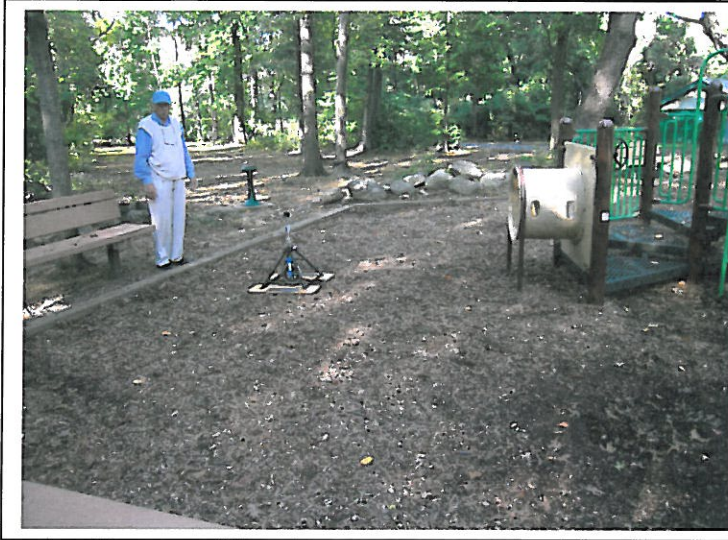
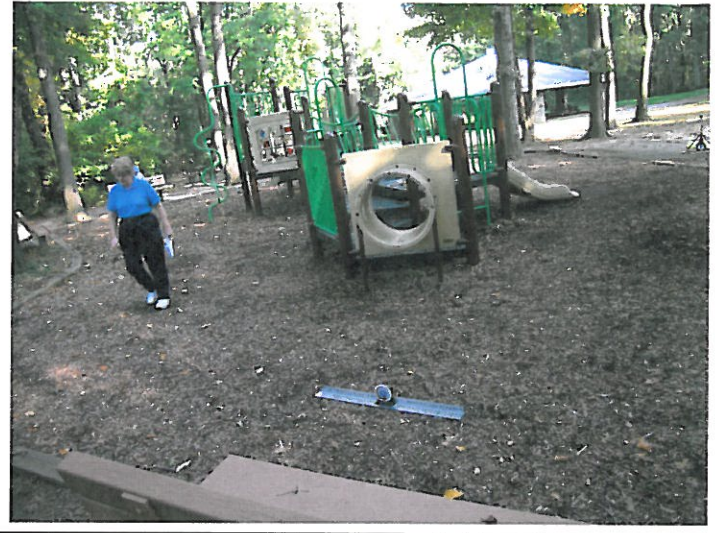
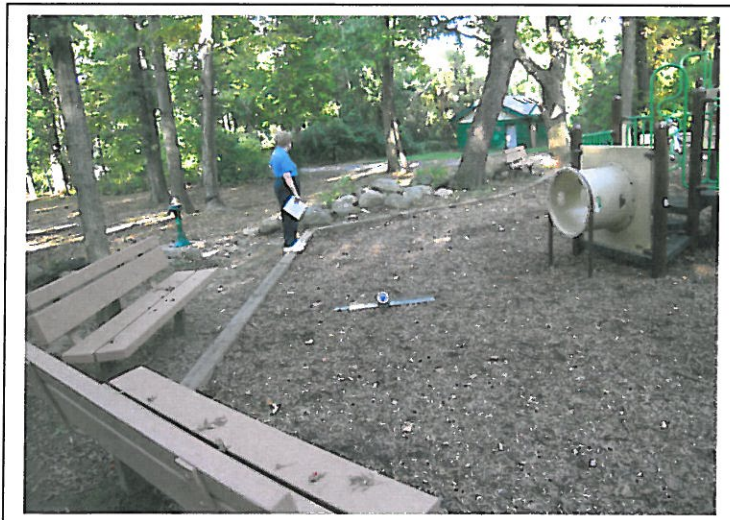
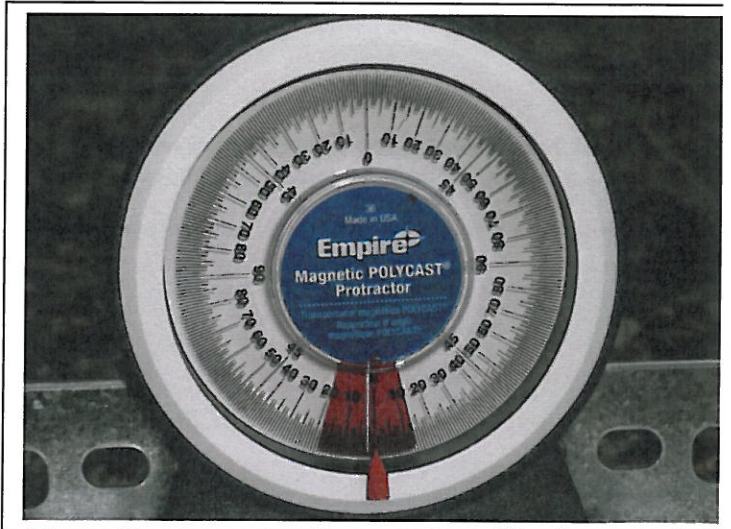
Area 5: Another accessible route within the playground

Firmness	Stability	Running Slope	Cross Slope	Change in Level	Openings	Surface Prep
.36	.65	0 %	3.5%	None	None	None

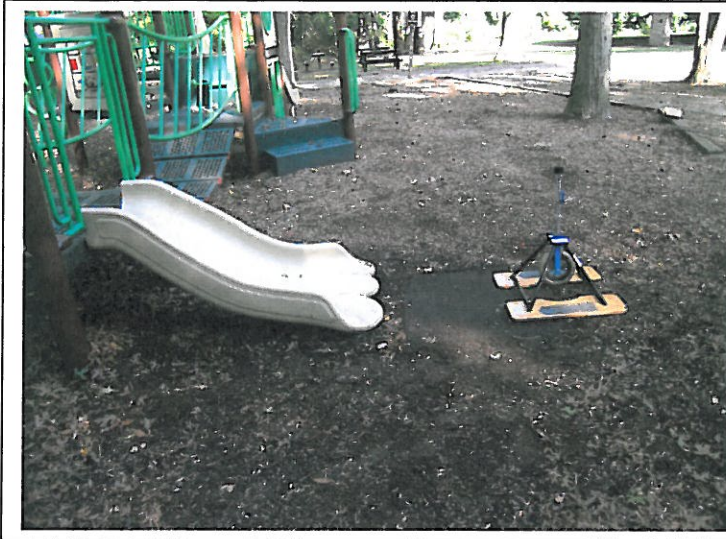
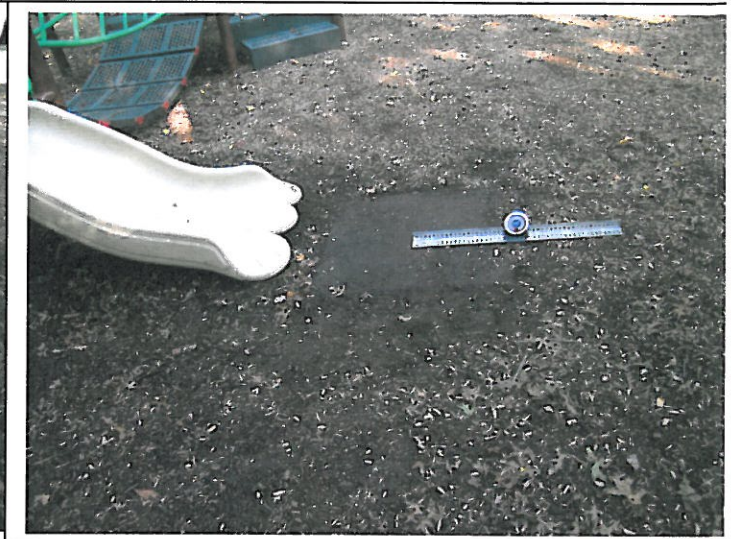
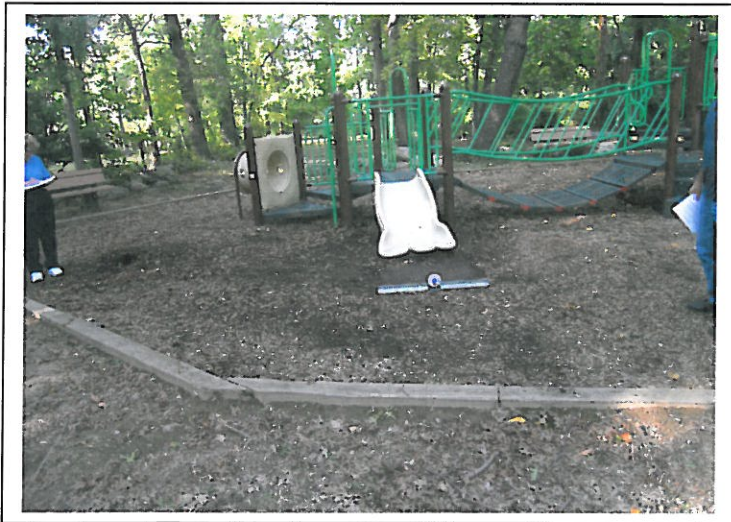
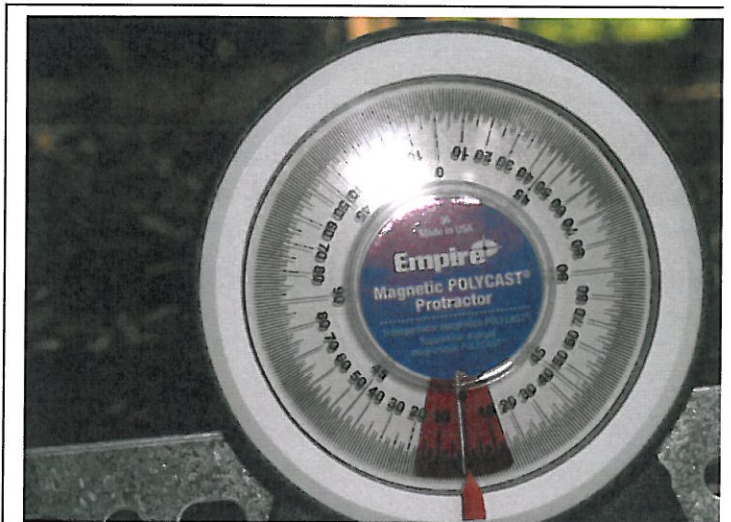
Area 6: Area at the base of a slide with a FibarMat wear mat on top of the surface

Firmness	Stability	Running Slope	Cross Slope	Change in Level	Openings	Surface Prep
.39	.44	1.75 %	3.5%	None	None	None

The FibarMat is a 3'x'3' wear mat with a beveled edge. The FibarMat was installed on top of the surface, recessed in the Fibar Engineered wood fiber. This is in accordance with Fibar's installation instructions.

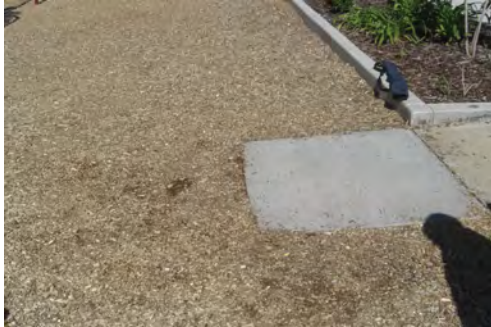
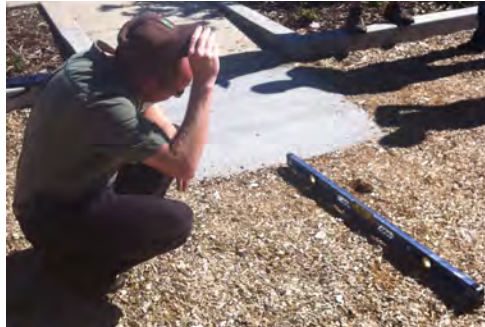
Location: Entry to play area from concrete walkway adjacent North-west picnic pavilion

Rotational Penetrometer Readings: Firmness - 0.36 Stability - 0.74

Slope: 2.5 Cross-Slope: 0.9

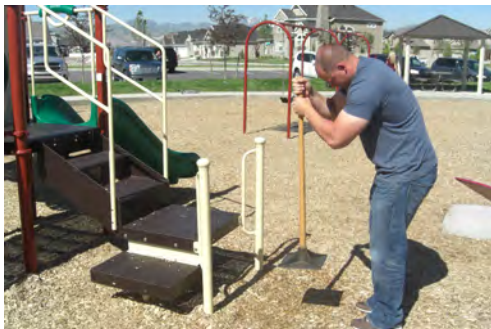
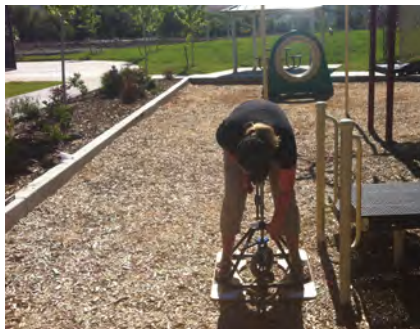
Location: North side of transition platform

Rotational Penetrometer Readings: Firmness - 0.33 Stability - 0.82

Slope: 0.1 Cross-Slope: 0.1

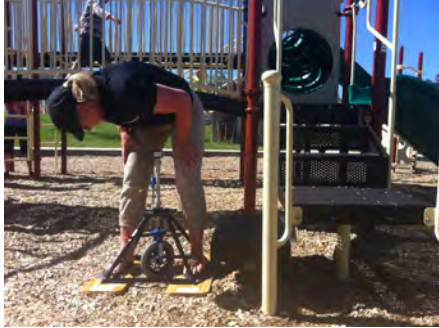
Location: East side of transition platform

Rotational Penetrometer Readings: Firmness – 0.34 Stability – 0.83

Slope: 1.7 Cross-Slope: 1.2

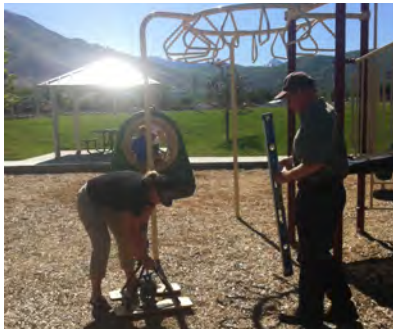
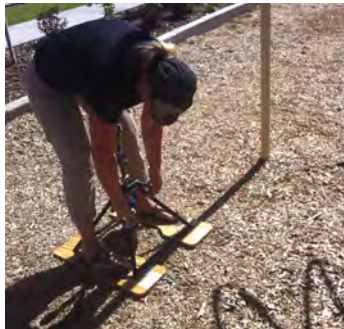
Location: Path between monkey bars and slide

Rotational Penetrometer Readings: Firmness – 0.34 Stability – 0.63

Slope: 0.4 Cross-Slope: 1.8

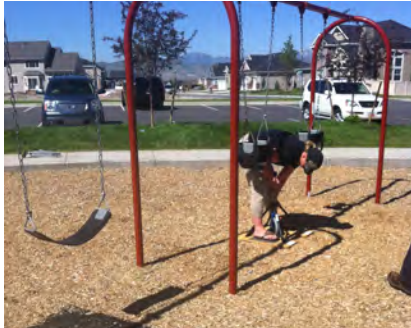
Location: Under toddler swings

Rotational Penetrometer Readings: Firmness – 0.22 Stability – 0.55

Slope: 0.2 Cross-Slope: 0.1

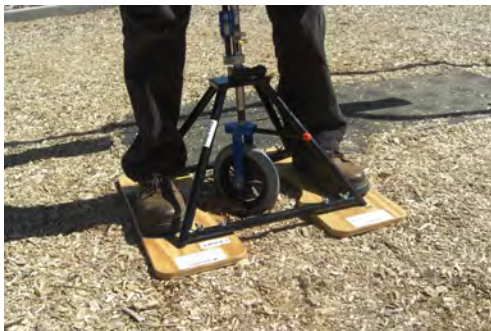
Location: Under swings next to near surface mat

Rotational Penetrometer Readings: Firmness – 0.35 Stability – 0.95

Slope: 2.3 Cross-Slope: 0.1

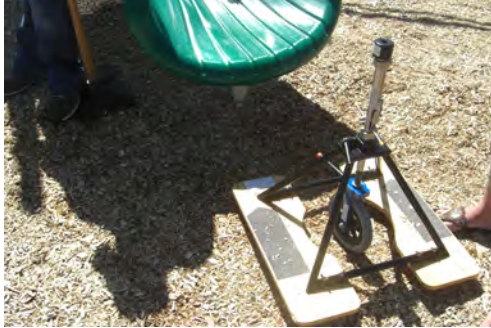
Location: Large slide exit

Rotational Penetrometer Readings: Firmness – 0.29 Stability – 0.99

Slope: 0.7 Cross-Slope: 0.1
