Engineered Wood Fiber
Accessibility Testing

Review and Analysis of Preliminary Results

8/20/2013

Henderson Consulting Services, Inc.

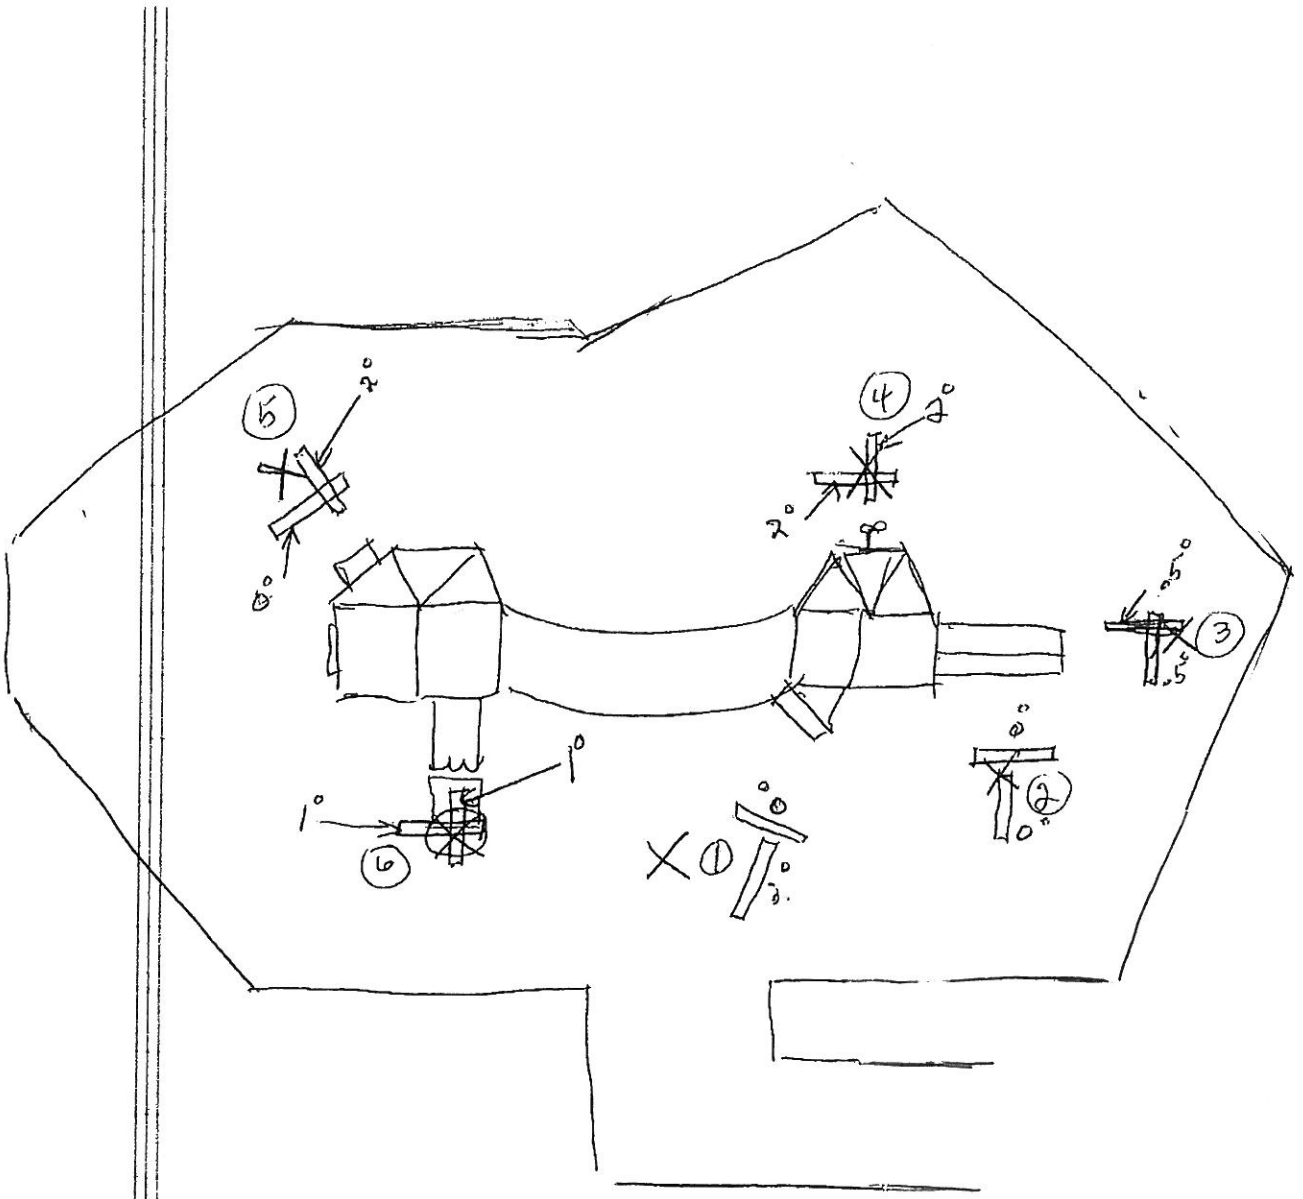
Area 6: Area at the base of a slide with a FibarMat wear mat on top of the surface

Firmness	Stability	Running Slope	Cross Slope	Change in Level	Openings	Surface Prep
.39	.44	1.75 %	3.5%	None	None	None

The FibarMat is a 3'x'3' wear mat with a beveled edge. The FibarMat was installed on top of the surface, recessed in the Fibar Engineered wood fiber. This is in accordance with Fibar's installation instructions.
